**Tree Report and Risk Assessment
Alamo Square**

Prepared for:
**Alamo Square Neighborhood Association
PO Box 15372
San Francisco CA 94115**

Prepared by:
**HortScience, Inc.
325 Ray Street
Pleasanton, CA 94566**

October 2011

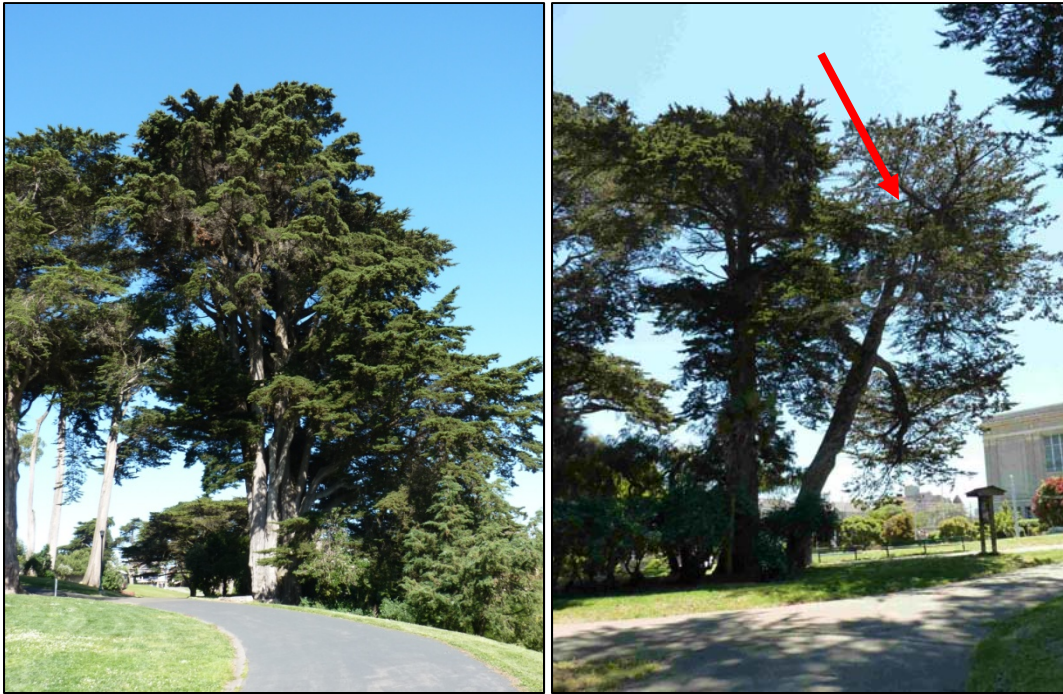
The most frequently occurring species was Monterey cypress with 79 trees (48%) (Photo 1, page 3). Trees were a diverse mix of size, age and condition. Trunk diameter ranged from 8" to 98" with the largest cypresses being #101 (98") and #79 (94"). Over half the cypresses had trunk diameters of 40" or greater. Tree age was similar with 56 of 79 trees in the mature category. Also present were 6 young, 9 semi-mature and 8 over-mature trees.

Young and semi-mature cypresses were more likely to be in good and excellent condition. Condition declined with age and size. Trees in good condition typically had dense canopies, symmetric form and vertically-oriented trunks. Trees in poor condition had decay, a history of failure, small canopies with twig dieback and other defects. Those in fair condition were intermediate.

Photo 1. Monterey cypress was represented by trees in good (left photo #37) and poor condition (red arrow, right photo #58).
